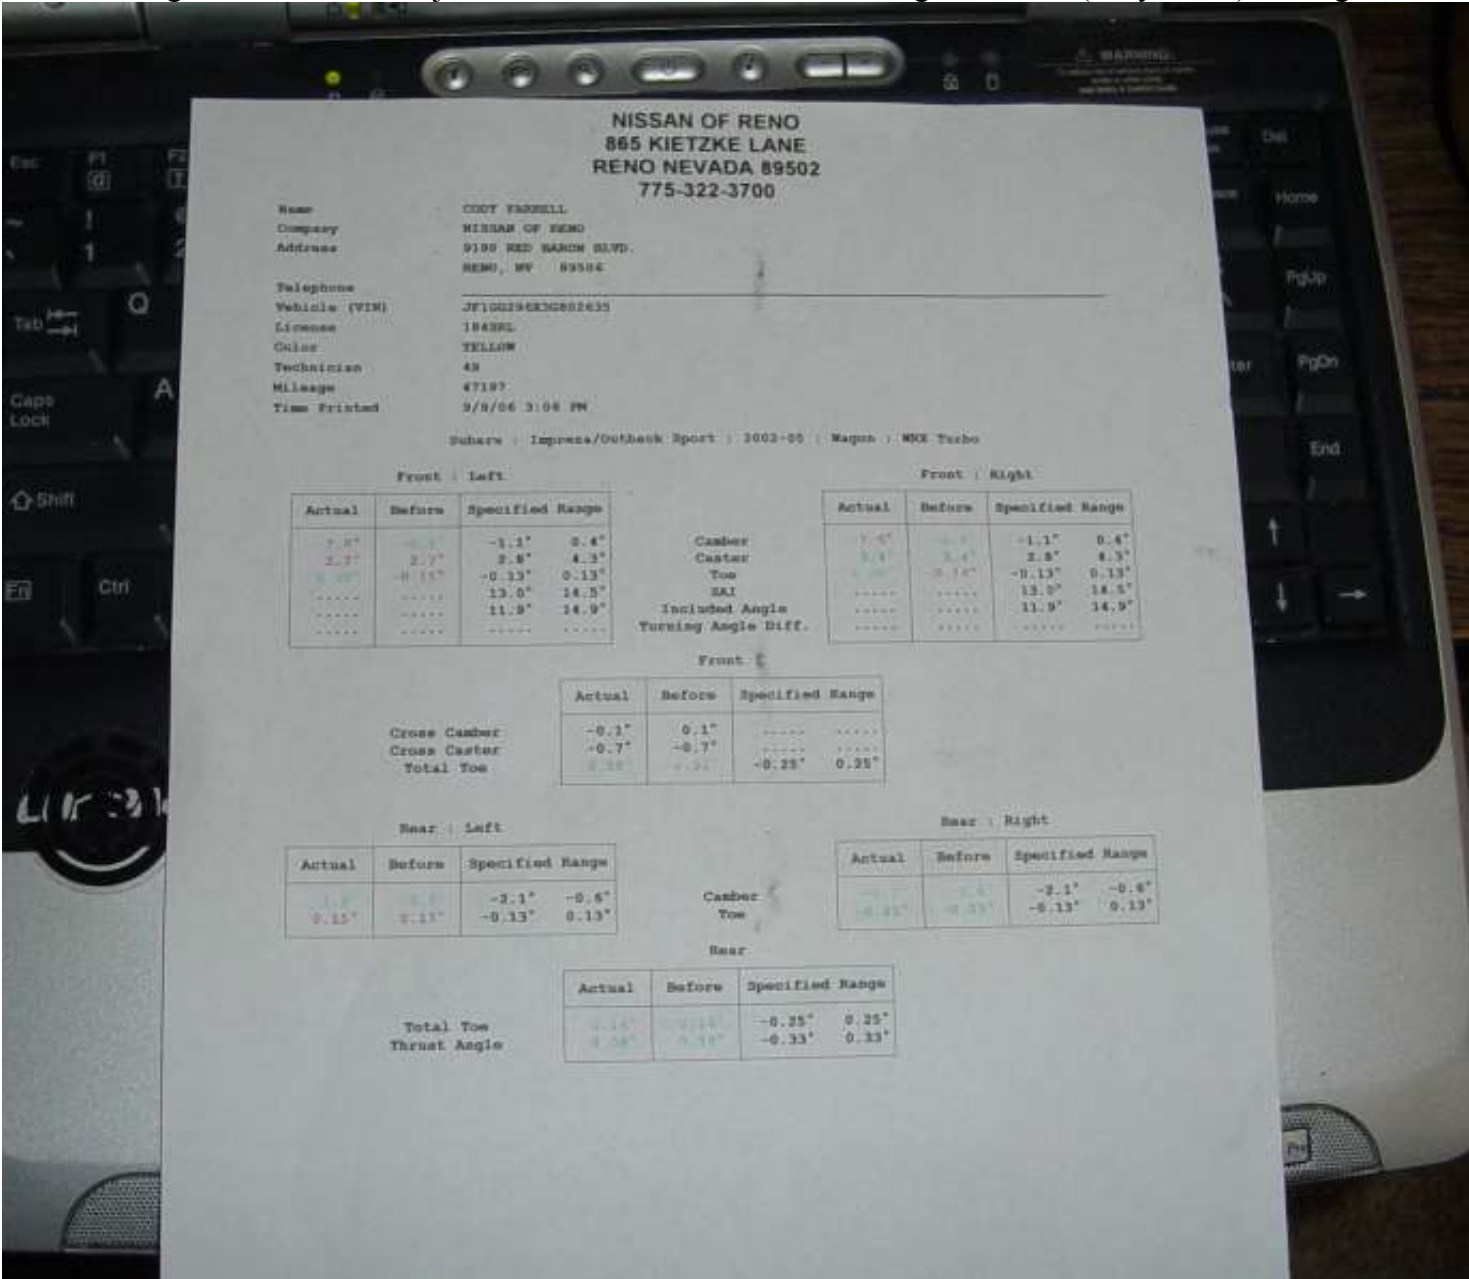
Yesterday I had the car aligned at Nissan of Reno. The only remaining issue with the alignment now is that the rear driver side wheel won't go to 0 toe at max adjustment. The closest to 0 that the alignment tech (Cory Davis) could get is .15 degrees.

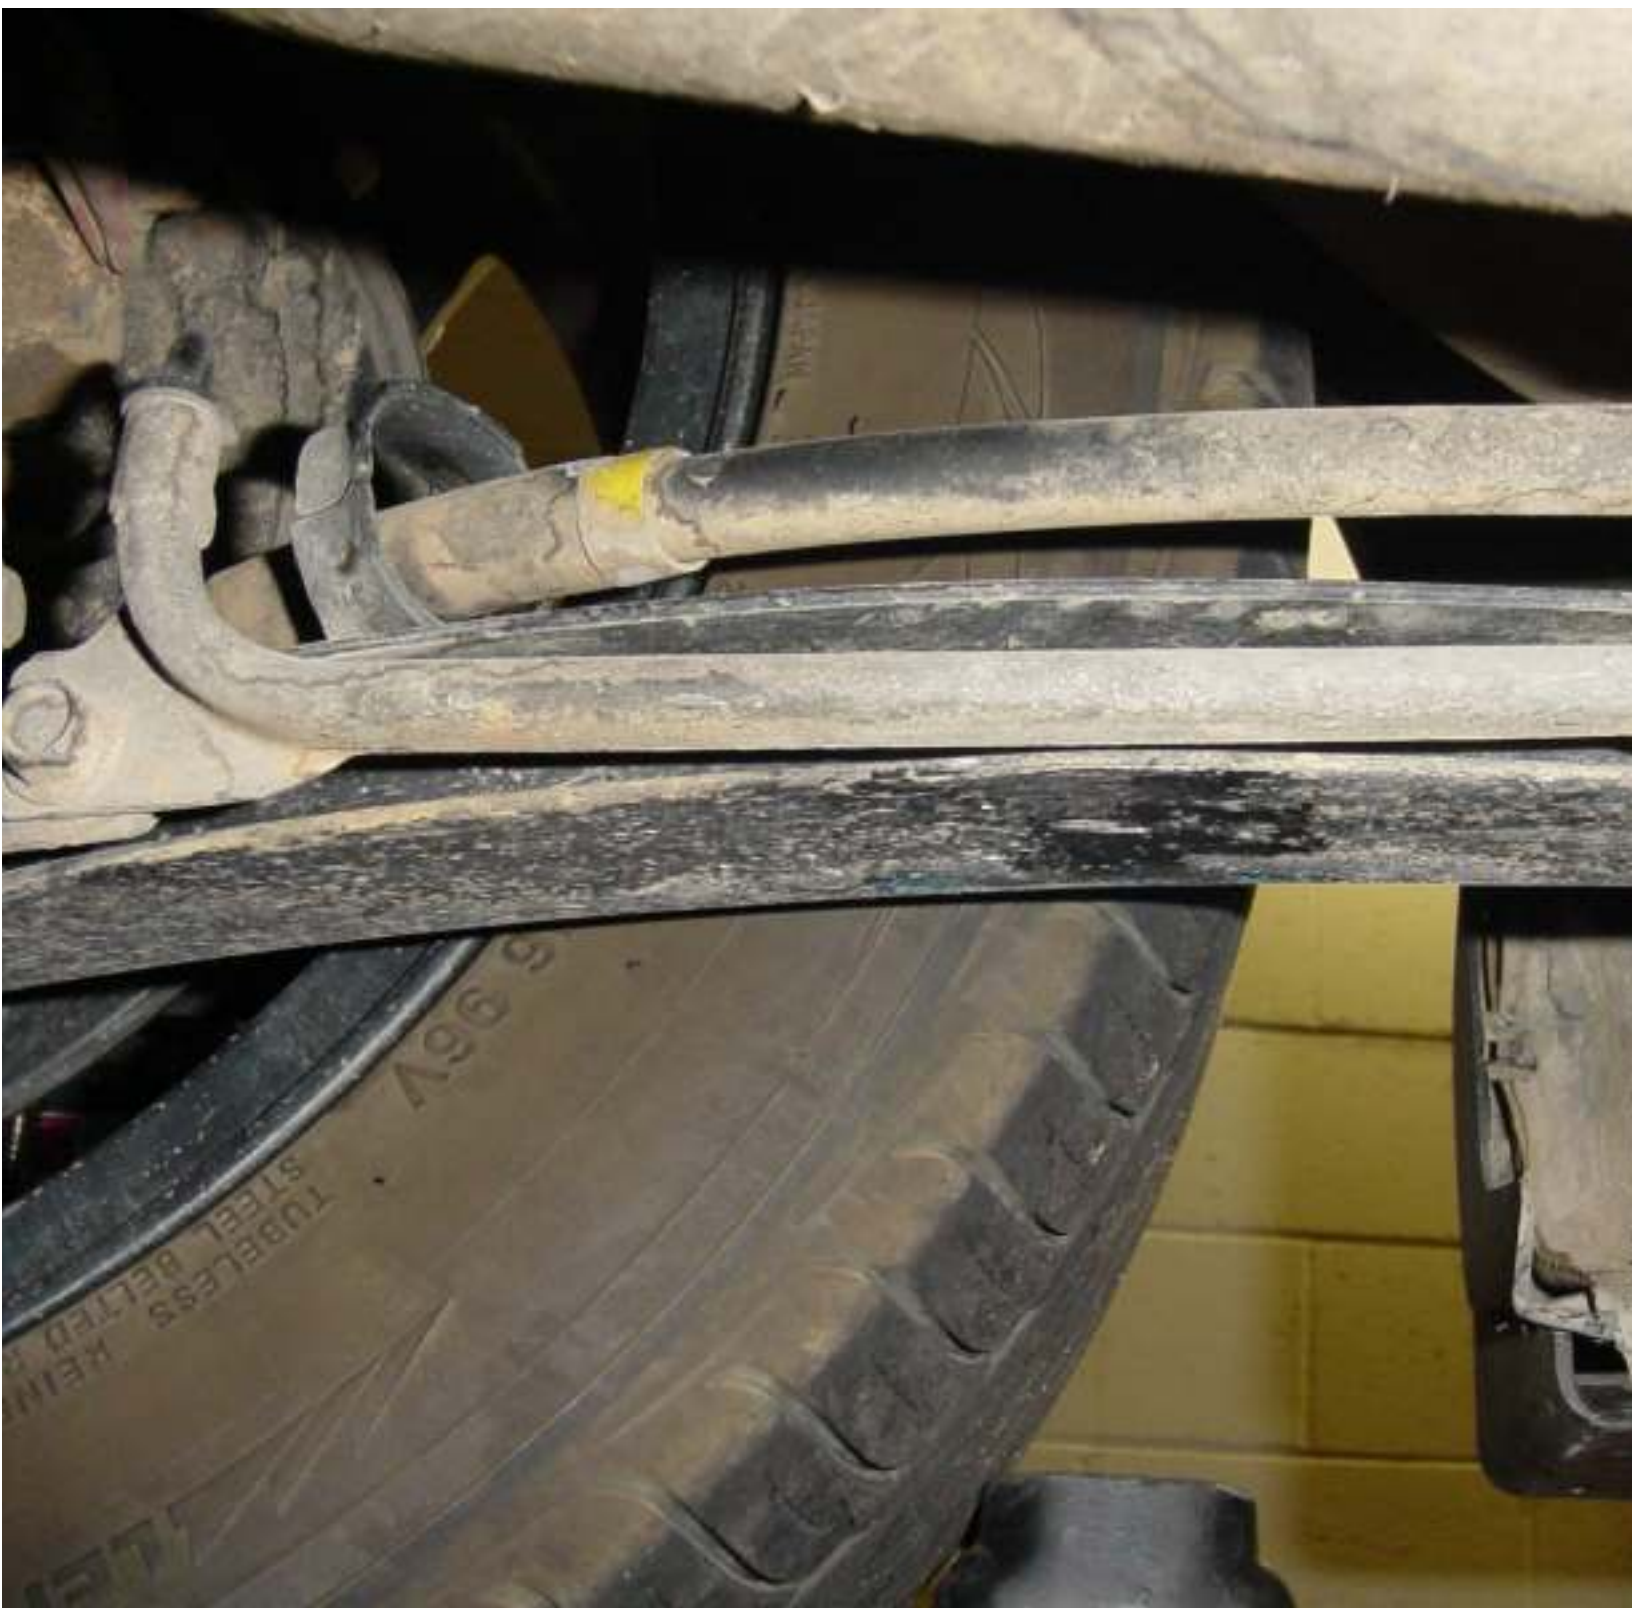
Passenger side rear trailing arm (bent):

We looked for damage that could explain this and we think we may have found it. The trailing arm in the driver side rear corner appears to be slightly bent from the accident. It looks like the arm struck a rock or something and is now bent in the bottom center of the arm. The bend would result in an effective shortening of the arm which would explain the excessive positive toe (toe in).

1. Can we please replace the driver side trailing arm and take any measurements that may reveal any other issues and repair those as well and then have Cory align that corner again so we can get it to 0 toe?
2. Can I please be reimbursed the \$96.71 that I paid Nissan of Reno for the alignment?

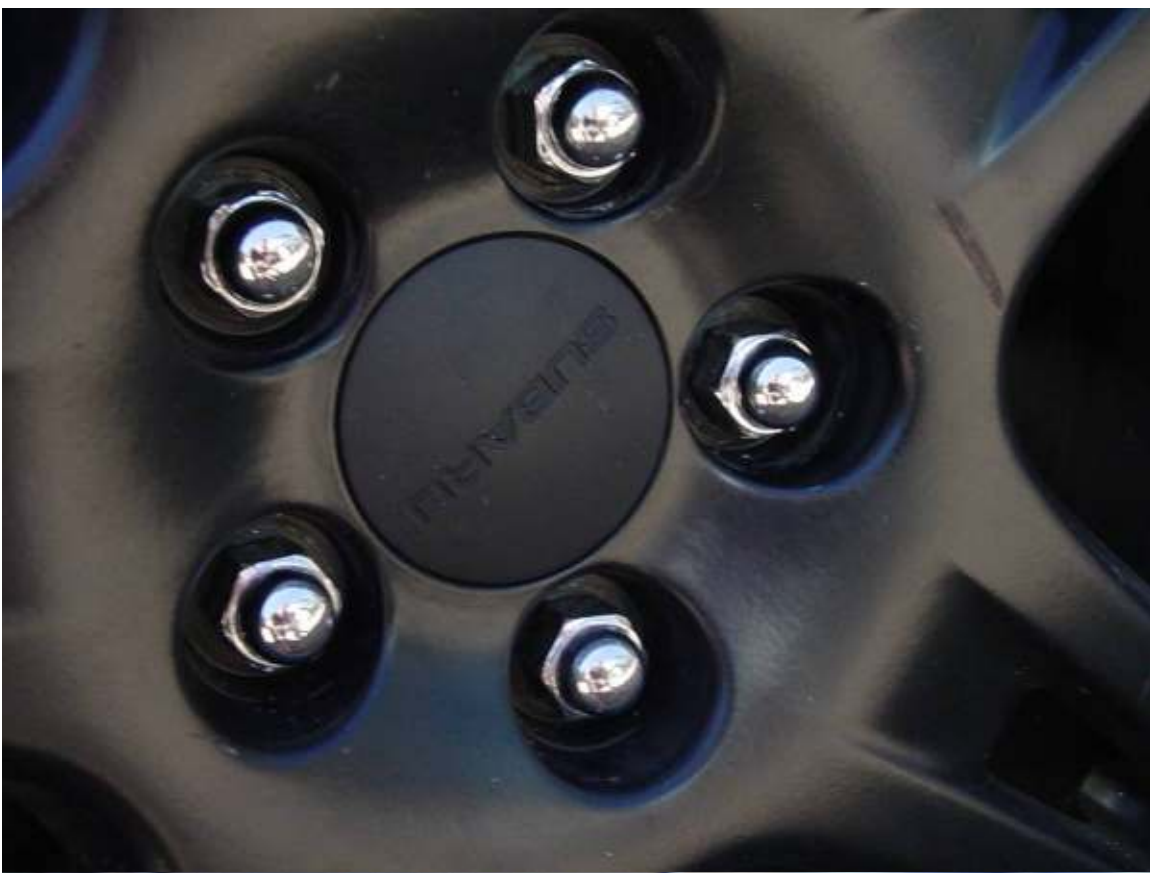
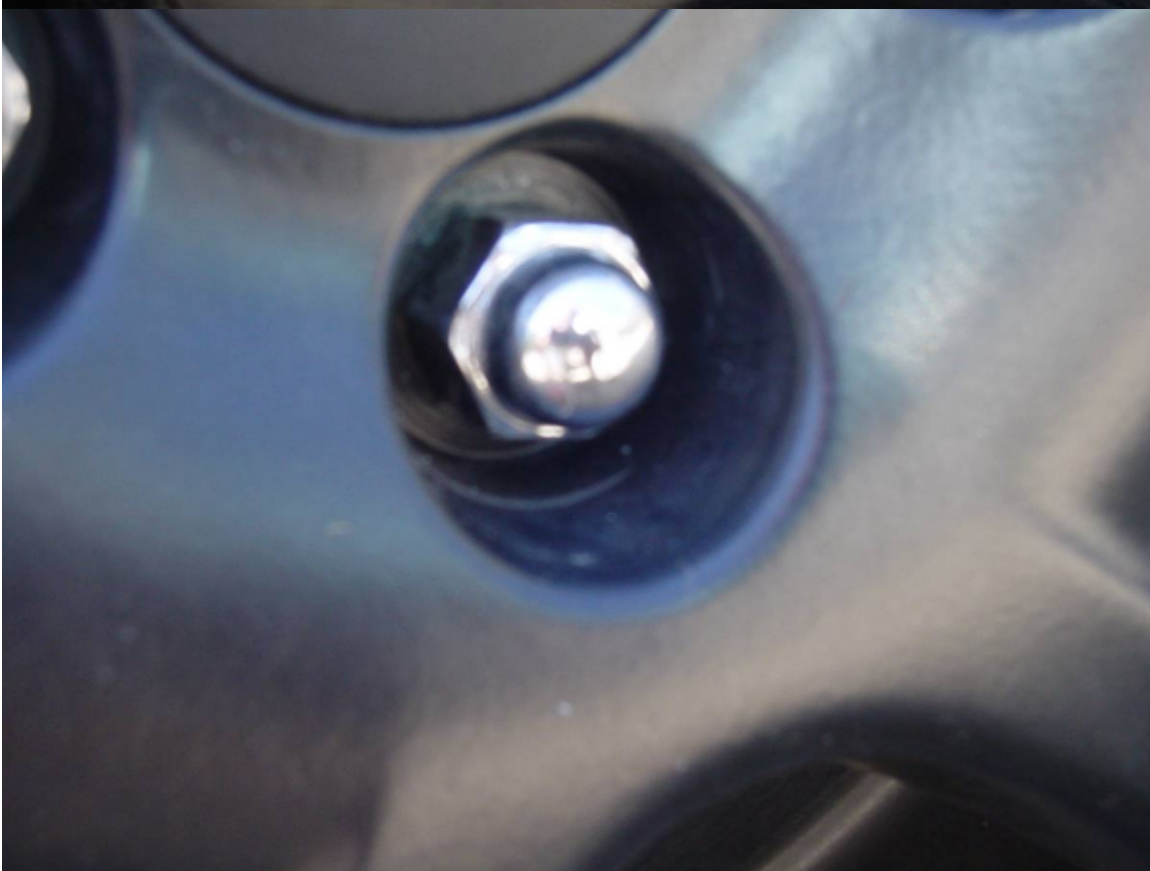
- b. Almost every lug nut hole in my powder coated (stock) wheels has scrapes from the socket that was used to install/remove the wheels. More care should have been taken to avoid this.

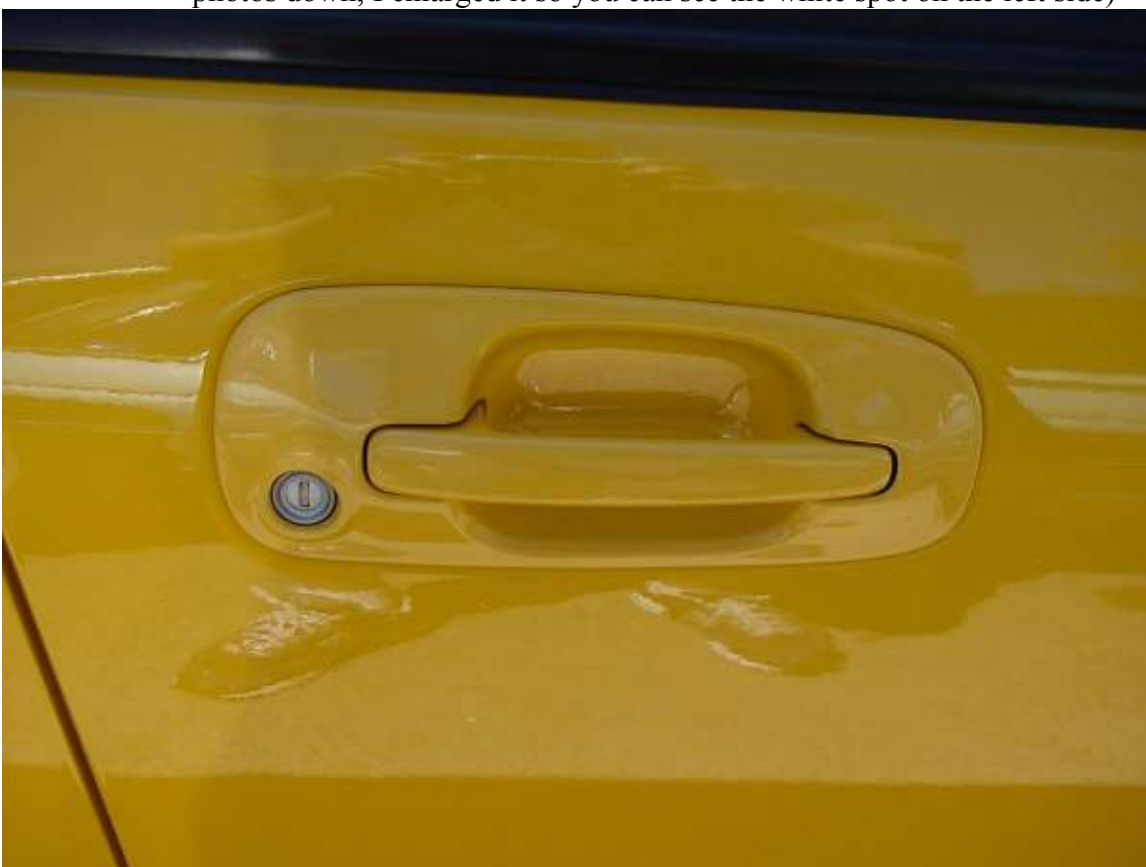
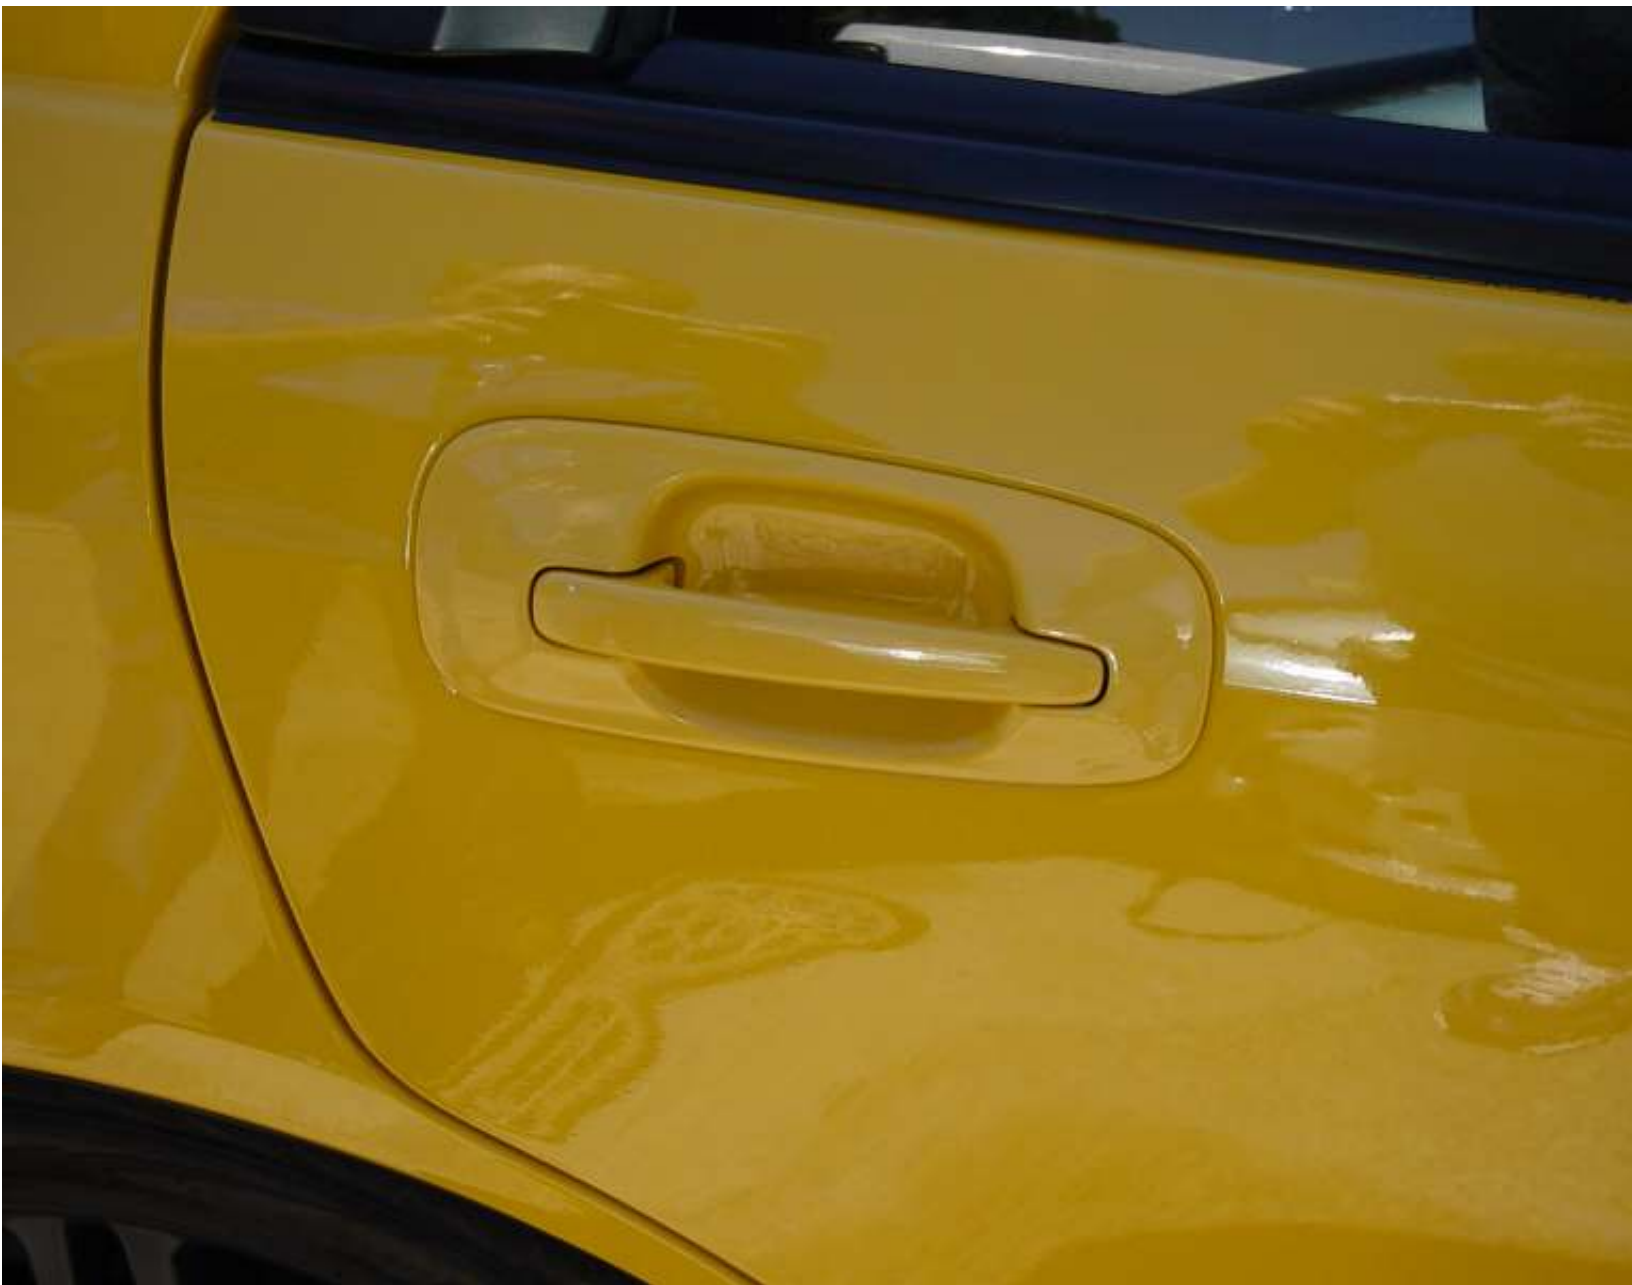
- c. The front and rear door handles on the passenger side don't match the new paint. They stick out like a sore thumb. Additionally there is a new paint chip on the rear passenger door handle that wasn't there before. (2 photos down, I enlarged it so you can see the white spot on the left side)

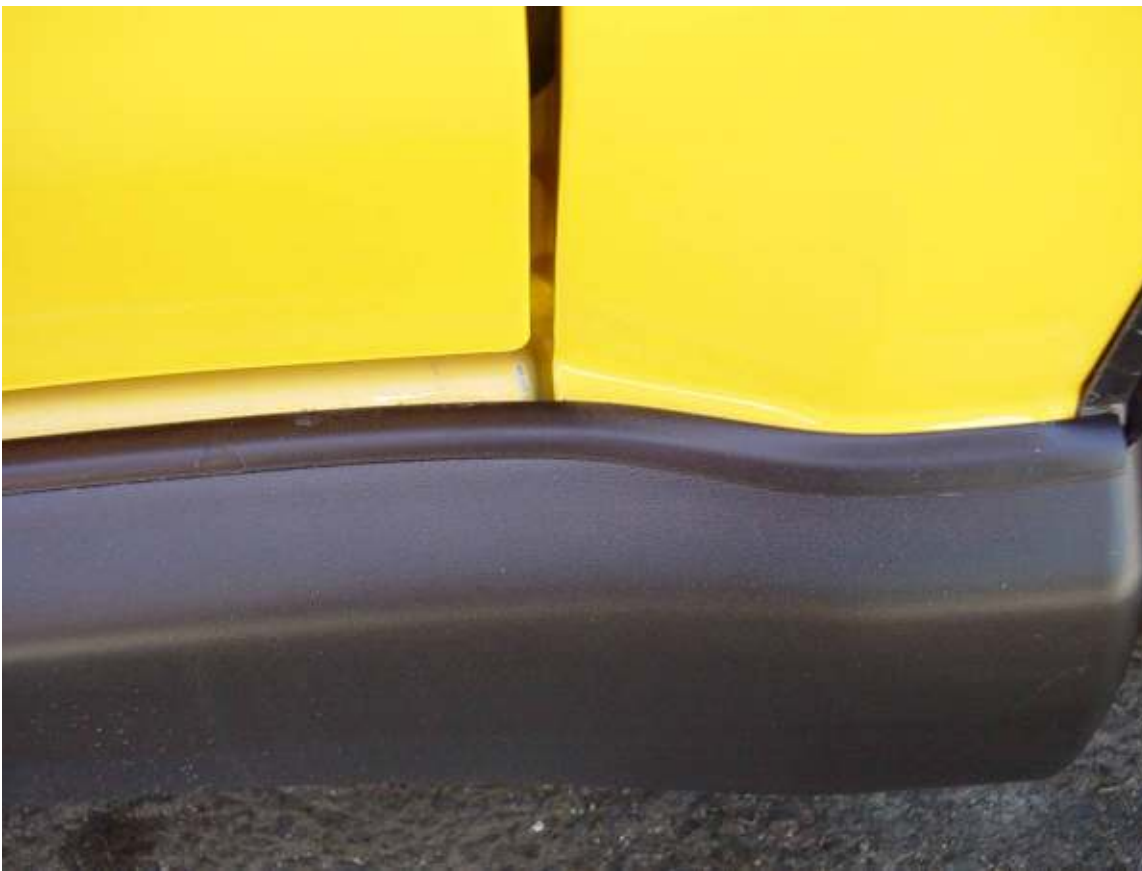
- d. Small scrape that goes down to the bare metal on the door sill above the side skirt (passenger side front door).

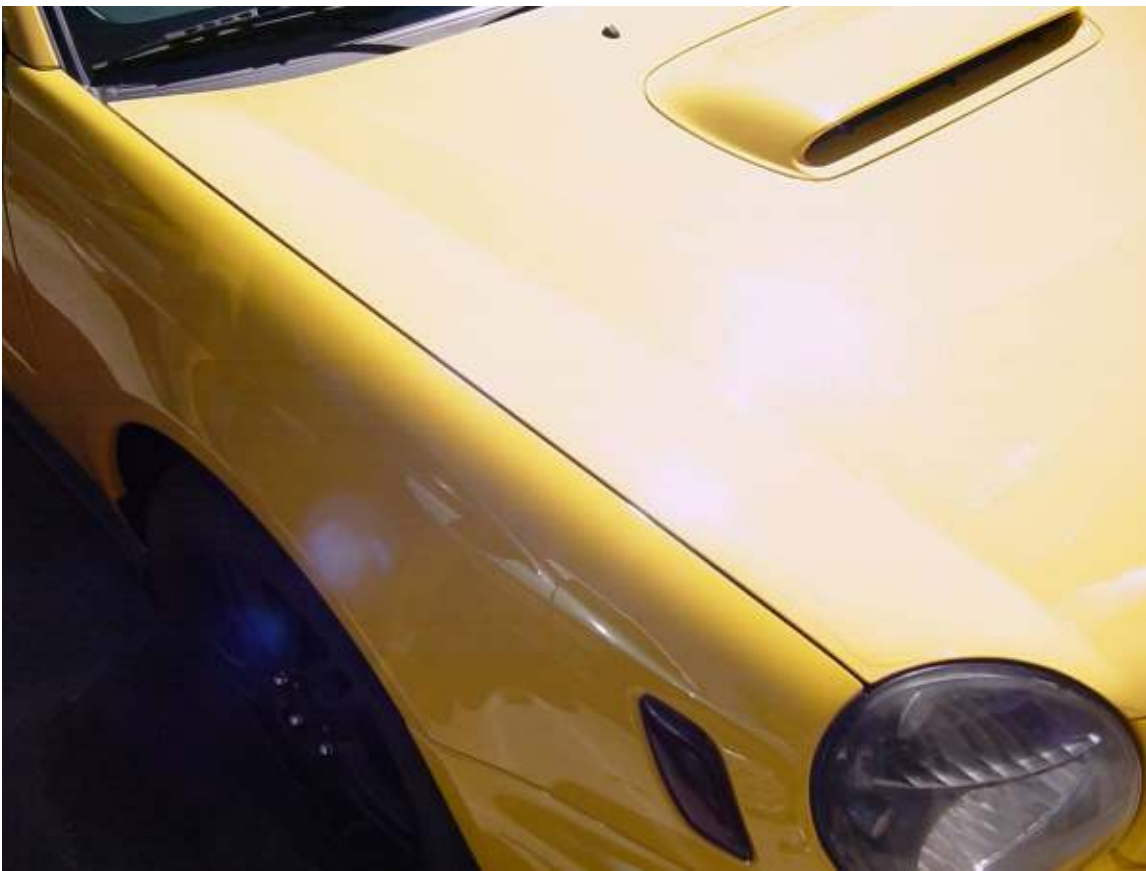
- e. The hood no longer matches the fender in color. This is very noticeable and looks awful. I was told Progressive doesn't pay for blend time where two body panels meet on two different planes, but you can see that the fender meets the hood on the same horizontal plane.

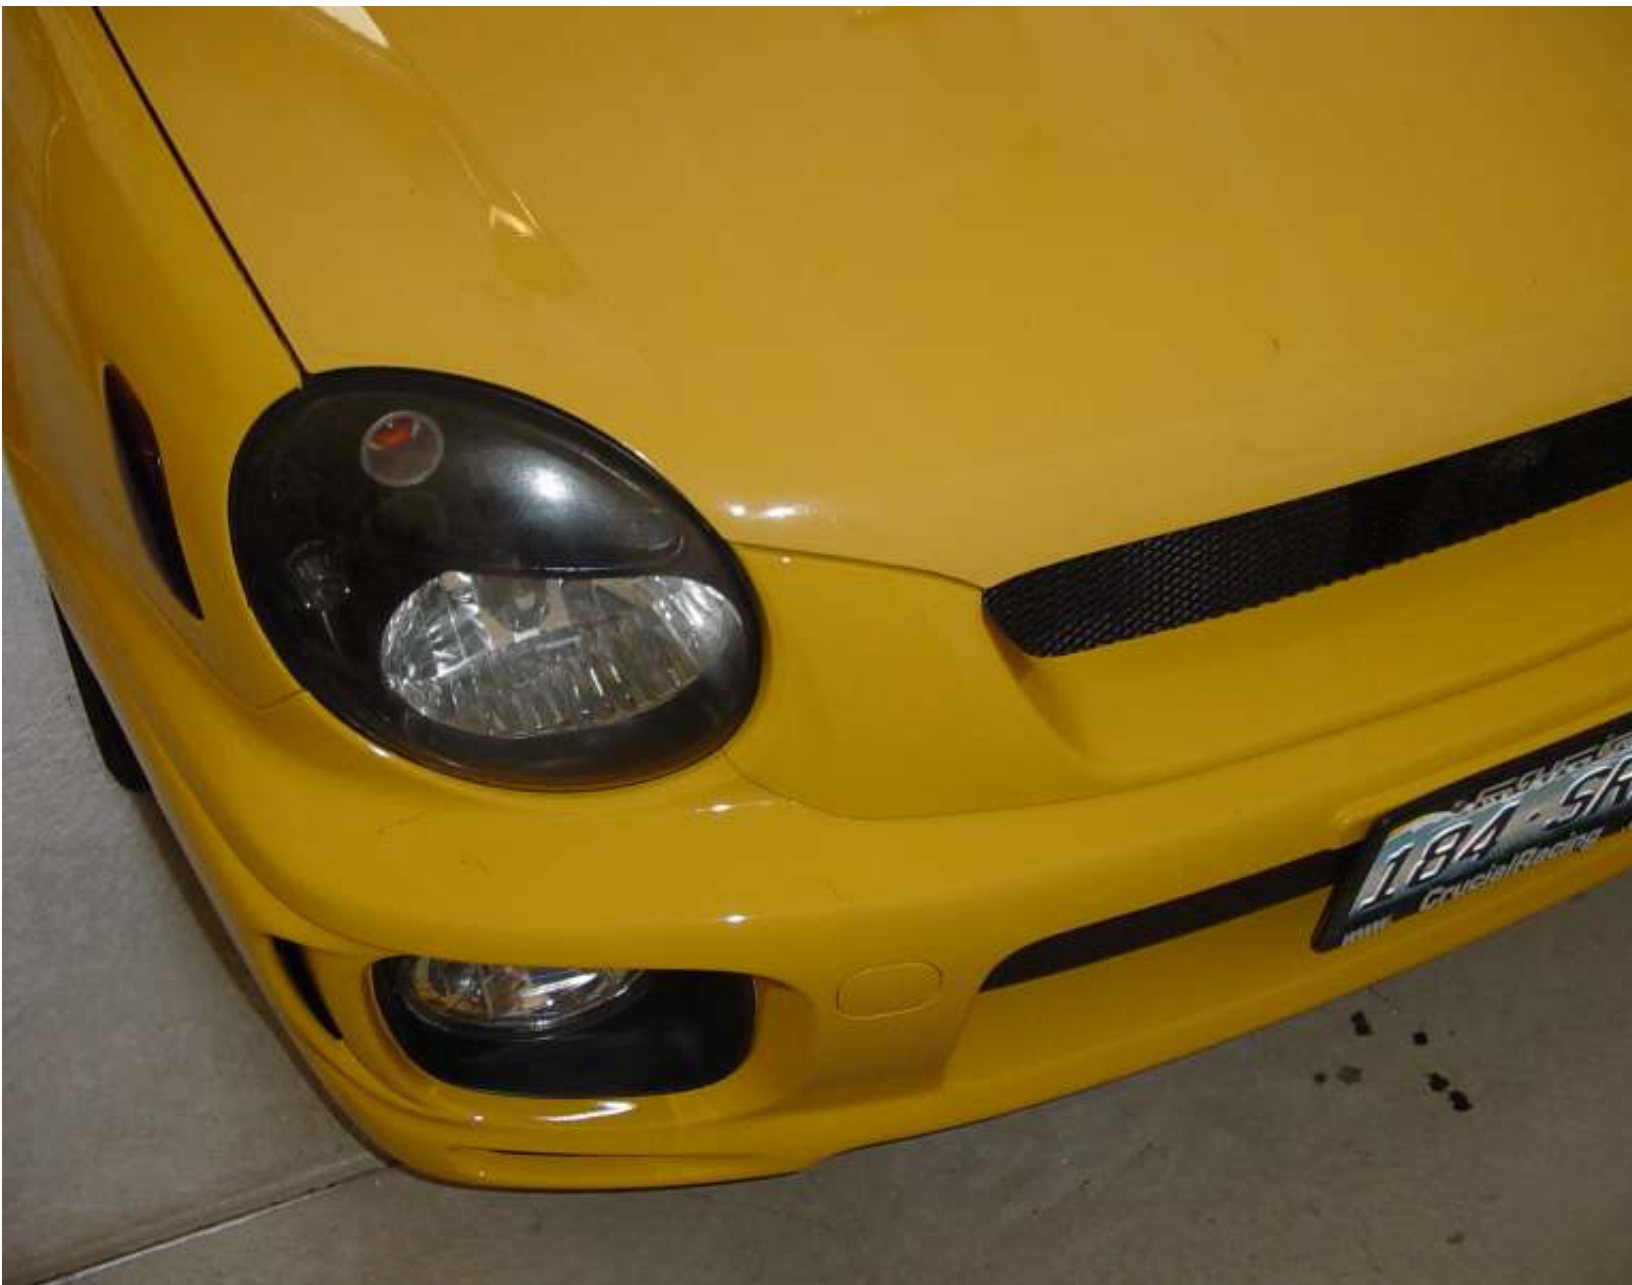
- f. Where the hood meets the grill, the paint doesn't match.

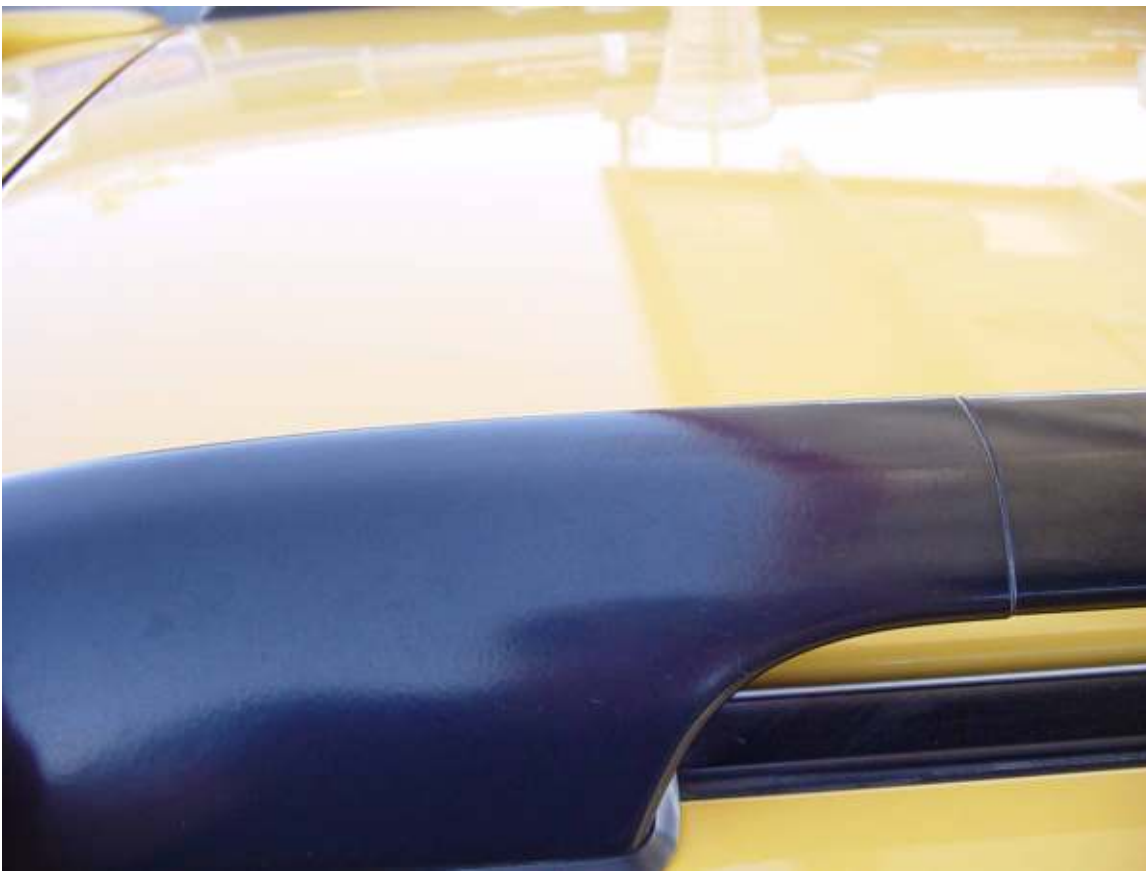
- g. There's a scrape on the top of the passenger side roof rail.
