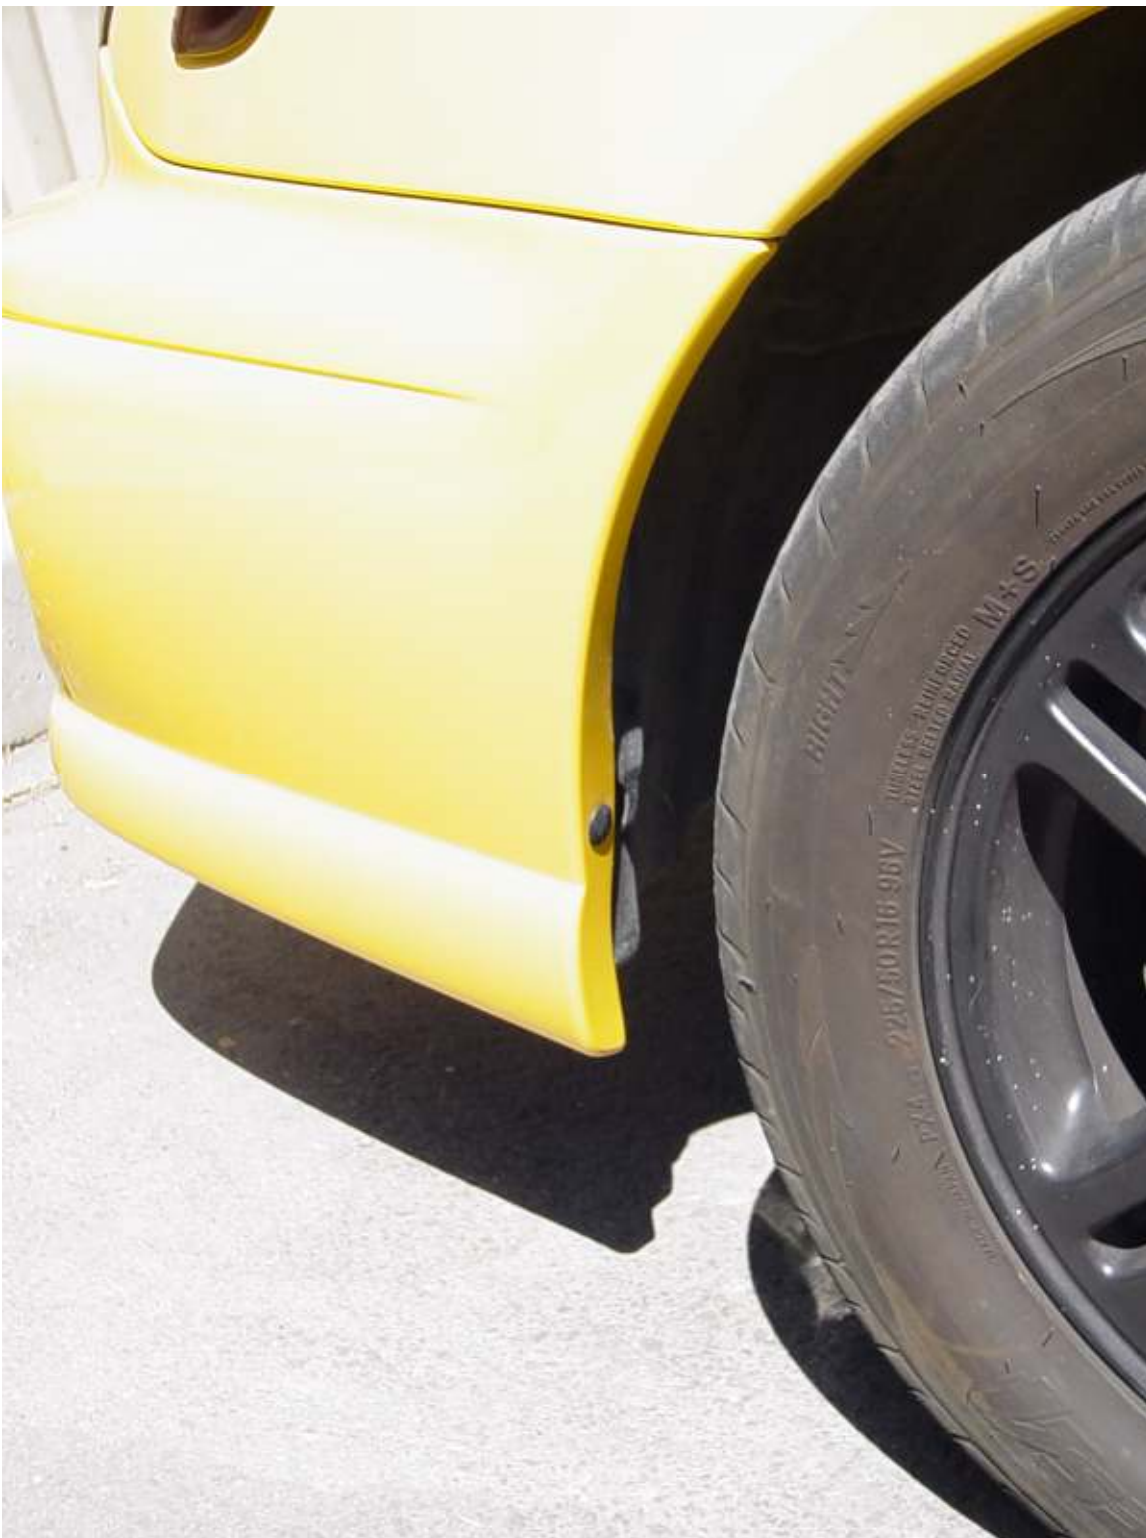
- b. Almost every lug nut hole in my powder coated (stock) wheels has scrapes from the socket that was used to install/remove the wheels. More care should have been taken to avoid this.
